CRITICAL STATE OF A WHEEL WORKING SURFACE

Abstract

Keywords: wheelsets, plasma, hardening, wear, reliability, microcracks

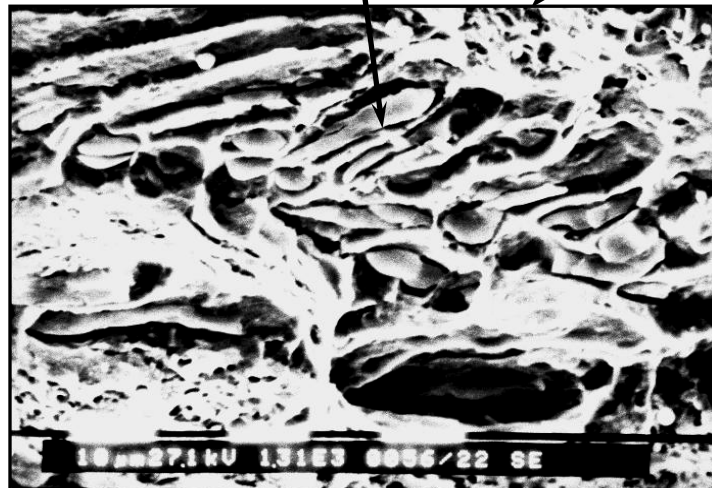
Fig.7

7. Fractography of the character of fracture

~30%Fe; ~29%Mn; ~39%S

~10%Fe; ~47%Mn; ~41%S

Examinations of the character of fracture (Fig. 7) show that the zone of about 100 μm contains the brittle cleavage regions. Analysis of the cleavage surface composition indicates that brittle fracture in this case is related to the presence of extended non-metallic inclusions, as well as to the structure gradient zones.

Therefore, the above-said allows a conclusion that one of the causes of propagation of cracks in the subsurface layers of the wheel shroud metal is formation of expanded elongated non-metallic inclusions of the sulphide type, oriented in parallel to the external surface. This relationship is most evident in fractographic examinations. Structure of metal is also related to cracking. Thus, as seen in the brittle fracture zones revealed by examination of fractures, the brittle cleavage regions propagate along the coarse laminae into pearlite grains, which is indicative of an unfavourable effect of structure of a coarse-laminated pearlite on mechanical properties of metal (and susceptibility of the above types of structural components to cracking).

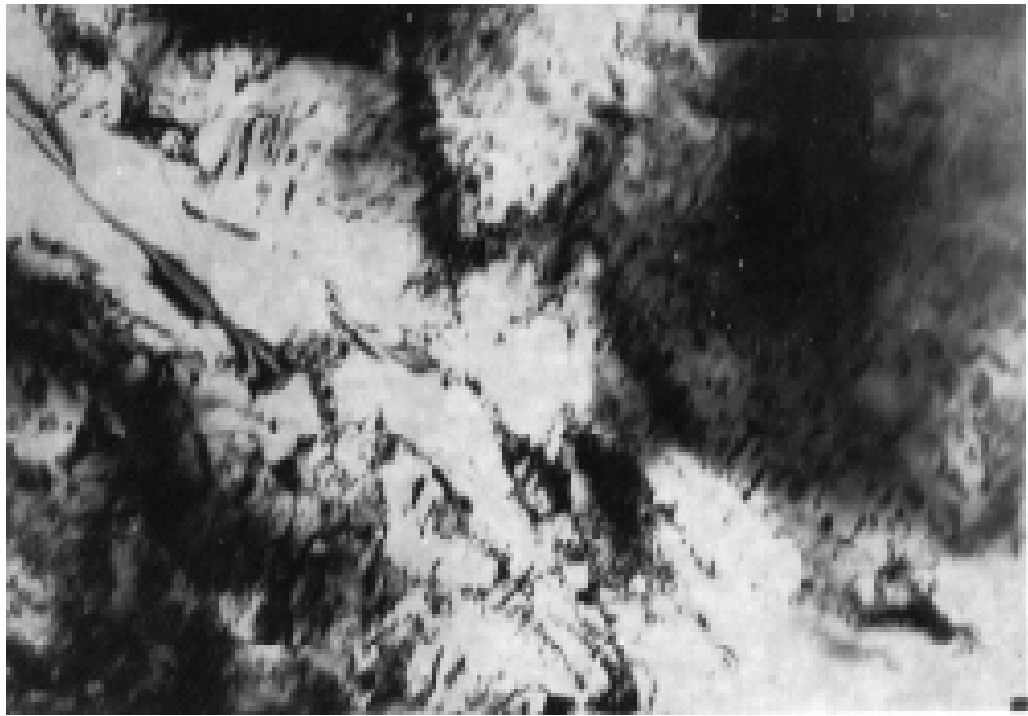
Fig.8

8. Path of a crack in the zone of gradient structures containing inclusions

Thirdly, transmission examinations of a fine structure showed that metal structure in the above zone had all the indicators of the presence of local and very high internal stresses. This implies a high level of dislocation density in the zone of pearlitic cementite laminae. The dislocation density in these regions amounts to about 10^{11}

cm⁻². The presence of a high level of local internal stresses is proved also by formation of extinction profiles in ferrite grains of small sizes (~ 0.1-1.0 μm), characterised by high curvature angles. The profiles are seen as a rule in the ferrite regions adjoining the stressed pearlite regions. Initiation and propagation of cracks take place mostly in these regions (Fig. 8).
